Service Manual

8065752478 Rev. B, CATALOG NO.
906-2150-001 Rev. B, TEXT ONLY

***Centurion** Vision System Service Manual**
8065752478

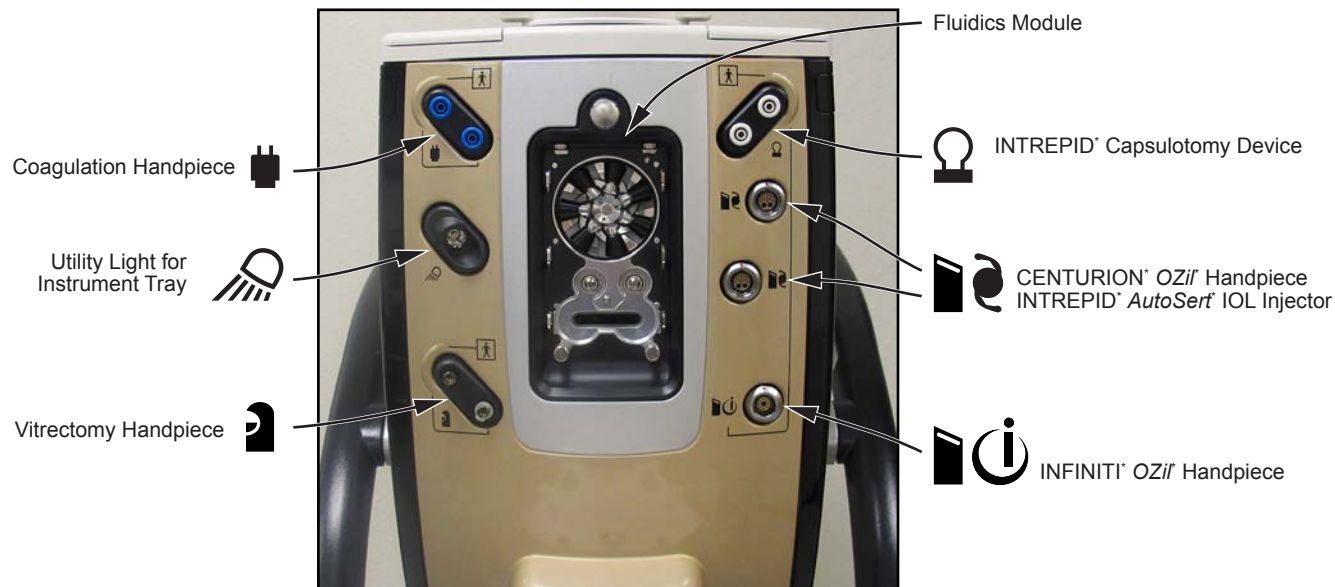
Figure 1-2 Front Panel Connectors

The front panel connectors are located on both sides of the fluidics module. The front panel connectors provide three self-locking phaco handpiece connectors, two connectors for the INTREPID® AutoSert® IOL Injector, one connector for a bipolar coagulation handpiece, connectors for the INTREPID® Capsulotomy Device, and luer lock pneumatic connectors for the *Centurion*® UltraVit® Probe. The left row of connectors also includes a utility light for the instrument tray. Symbols near the connectors facilitate handpiece identification.

The *Centurion*® OZil® handpiece is recognized in the top two phaco handpiece connectors; only the INFINITI® OZil® handpiece is recognized in the bottom. Only one phaco handpiece can be connected at one time in either connector, unless the UltraChop feature is enabled in which case the system will accept two phaco handpieces.

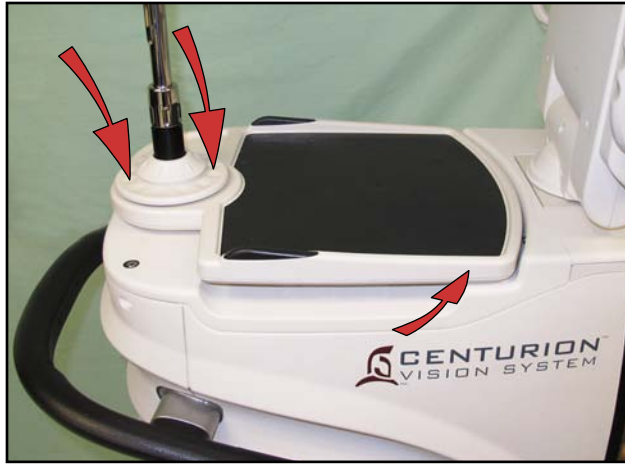
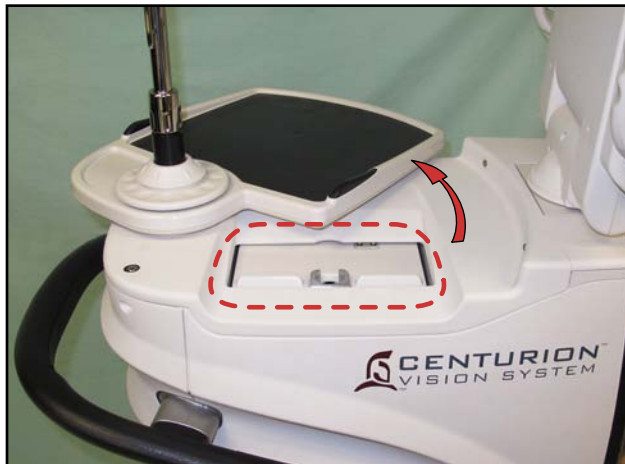
Figure 1-4 Rotating Work Surface

To rotate the work surface and reveal the bag bay, press and hold the locking ring while pressing sideways on the work surface (see top image in *Figure 1-4*). The right image shows the work surface in the open position, allowing access to the bag bay. Once open, the surface can be rotated until the mechanical lockout feature prevents further rotation. When Active Fluidics[®] technology is used, this lockout feature prevents inadvertent contact of the work surface against the bag of BSS[®] irrigating fluid and its tubing. To return the work surface back to its stowed position, press and hold the locking ring and press sideways on the work surface.

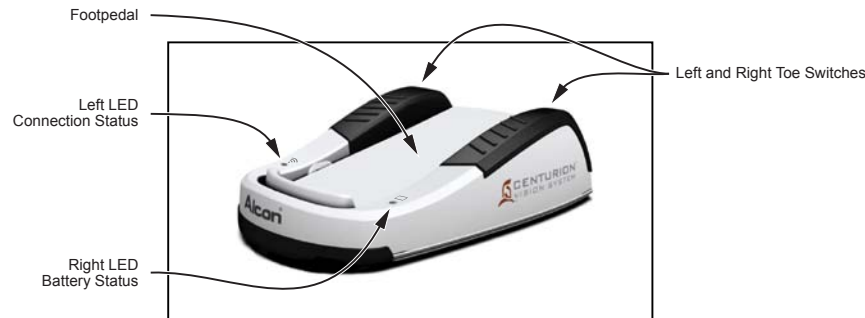
Figure 1-5 The *Centurion** Footswitch

The *Centurion** footswitch, shown in *Figure 1-5*, can be used wirelessly or can be wired to the console. When the footswitch is operated wirelessly, it retains the same functionality as it does when it is wired to the system. The wireless footswitch is immune to interference from other wireless devices.

Several functions within the system's operating modes are controlled by the surgeon using the footswitch. The footpedal enables the surgeon to control irrigation flow, aspiration rate, capsulotomy activation, phaco handpiece power, vitrectomy cutting, coagulation power, and IOL injection. The switches are used to turn functions on/off, to adjust function settings, and to progress through surgical steps.

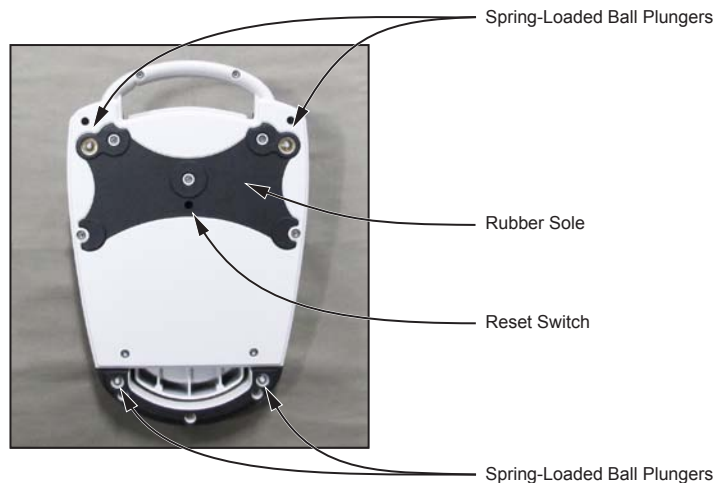
Figure 1-6 Bottom of Centurion® System Footswitch

The footswitch has four spring-loaded ball plungers at each corner of the bottom plate (see *Figure 1-6*). These ball plungers are designed to allow easy sliding of the footswitch on a smooth floor, and yet still offer secure floor gription when the weight of the surgeon's foot is resting upon it.

The weight of the surgeon's foot on the footswitch causes the spring-loaded ball plungers to collapse, allowing the footswitch to rest on its rubber sole, thus preventing it from sliding on the floor. The tension of the spring-loaded ball plungers is adjustable to the surgeon's preference using a wide, flat-tip screwdriver. Simply place the screwdriver directly on top of the ball and press down until the screwdriver tip settles into the screw slot, then turn clockwise or counterclockwise to increase or decrease the spring tension.

A power reset switch is located in the bottom of the footswitch. In the case that a reset is required, simply press a cotton swab into the small hole in the bottom to depress the switch and turn power back on (see *Figure 1-6*). Re-pairing of the footswitch will restore the previously-programmed footswitch settings.

- 4.2 Set the footswitch to “shipping” mode by pressing the switch shown in *Figure 1-6* with a cotton swab or other instrument that can reach the recessed switch without damaging the rubber covering.

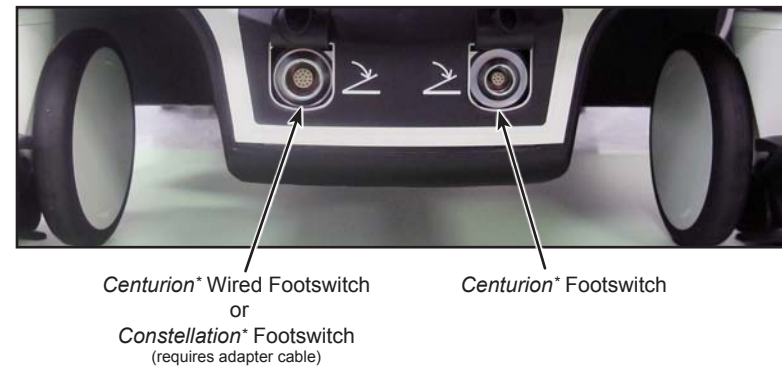
Figure 1-7 Footswitch Connector Panel

The Centurion® footswitch can be wired to the system, while the Centurion® Wired and Constellation® footswitches must be wired. *Figure 1-7* shows the footswitch connector panel located at the bottom-front of the system.

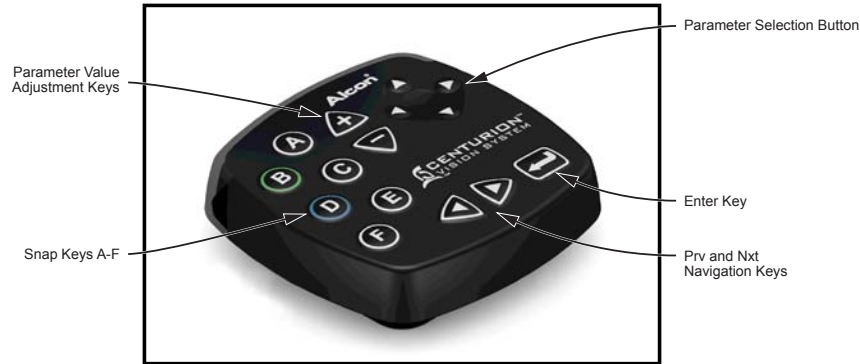
Figure 1-8 Infrared (IR) Remote Control

The infrared (IR) remote control shown in *Figure 1-8* allows the user to quickly navigate procedure steps and make simple parameter value adjustments.

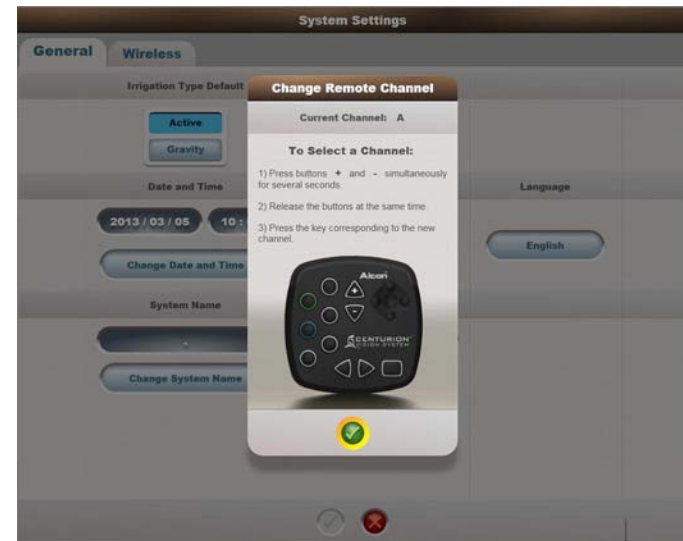
Figure 1-10 Change Remote Channel Dialog

To select a remote channel, press the Custom key and select System Settings/General tab. Select the Change Remote Channel button and follow the on-screen instructions (see *Figure 1-10*). No additional steps are needed once the remote channel is set, and only one remote channel is stored per unit.

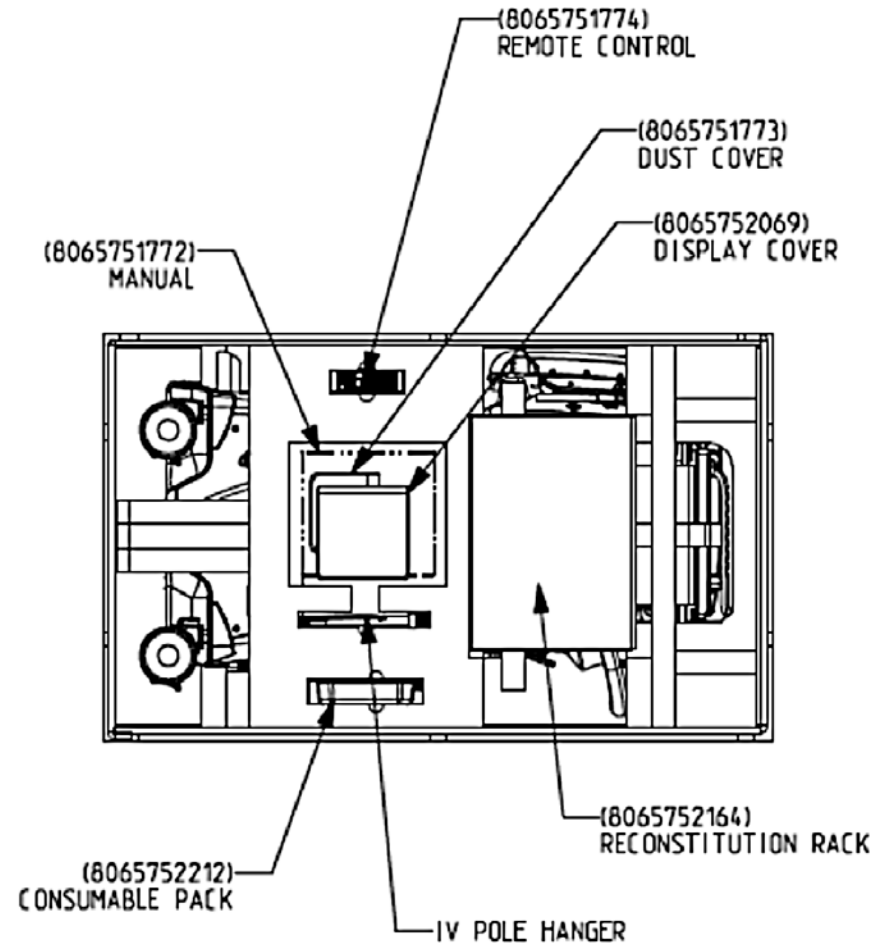
Figure 1-12 Packing Configuration

- 1.1.1 Cut the packing straps and then remove the top cover. Refer to *Figure 1-12* for packing configuration.
- 1.1.2 Remove all the accessories and set aside; (operator's manual, dust cover, display cover, remote control, IV pole hanger, cassette pack and reconstitution BSS bag rack)

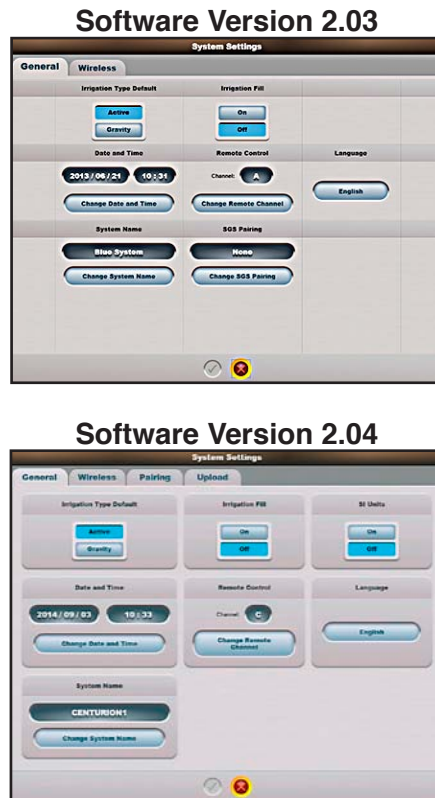
Figure 1-13 System Settings - General Tab for Setting Date and Time

- 1.4.1 Plug console into power outlet and turn on.
- 1.4.2 Navigate to |System Settings|General| to set the Date & Time (see Figure 1-13).

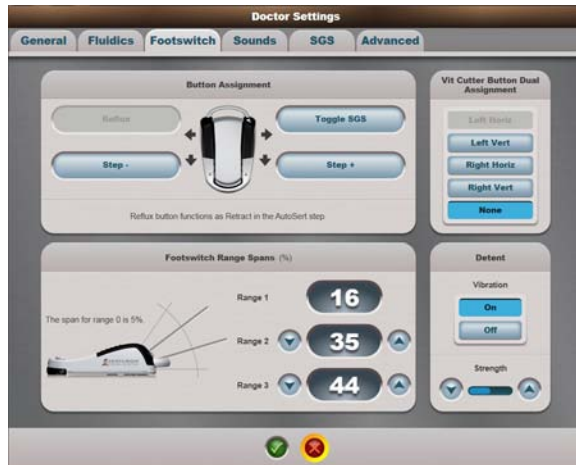
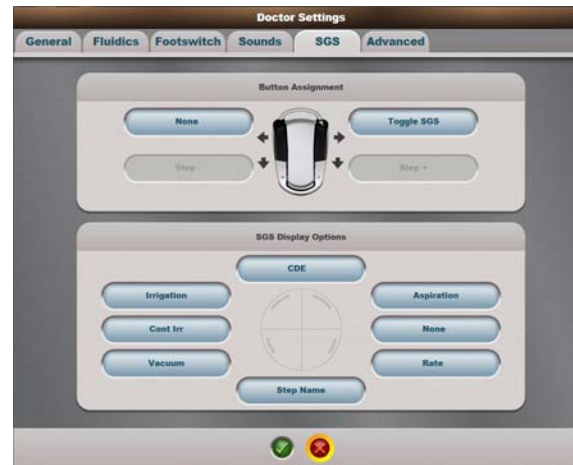
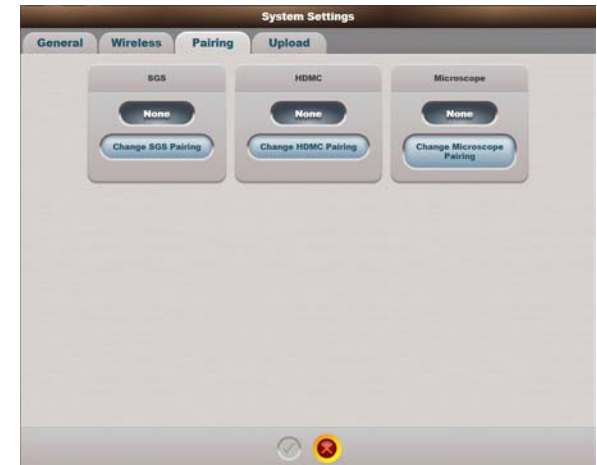
Figure 1-15 Pairing the *Verion** Digital Marker Microscope with the *Centurion** System

1. Doctor Settings: Designate *Centurion** footswitch.

2. Doctor Settings: Designate SGS Display Options Button Assignments.

3. System Settings: Select Change SGS Pairing.

4. System Settings: After setting up *Verion** DMM wireless, press Find.

5. System Settings: Select Pair.

6. System Settings: Press the green check button.

In order to successfully pair a *Verion** Digital Marker Microscope (DMM) with a *Centurion** System, follow the instructions below and refer to *Figure 1-15*.

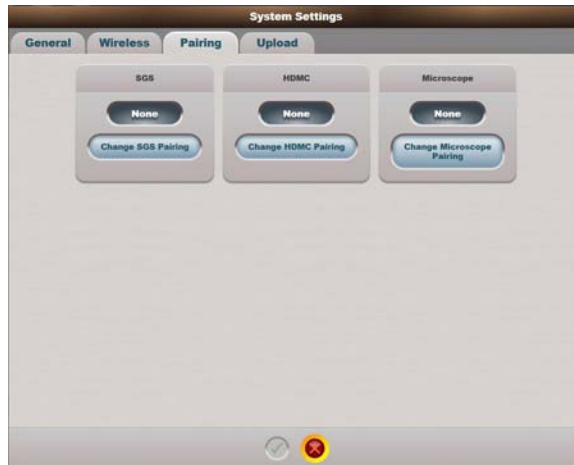
Figure 1-16 Pairing LX3 Microscope with the Centurion* System

1. Select Change Microscope Pairing.

2. After setting up LX3 wireless, press Find.

3. Select Pair.

4. Press the green check button.

In order to successfully pair a LX3 microscope with a *Centurion** System, follow the instructions below and refer to *Figure 1-16*.

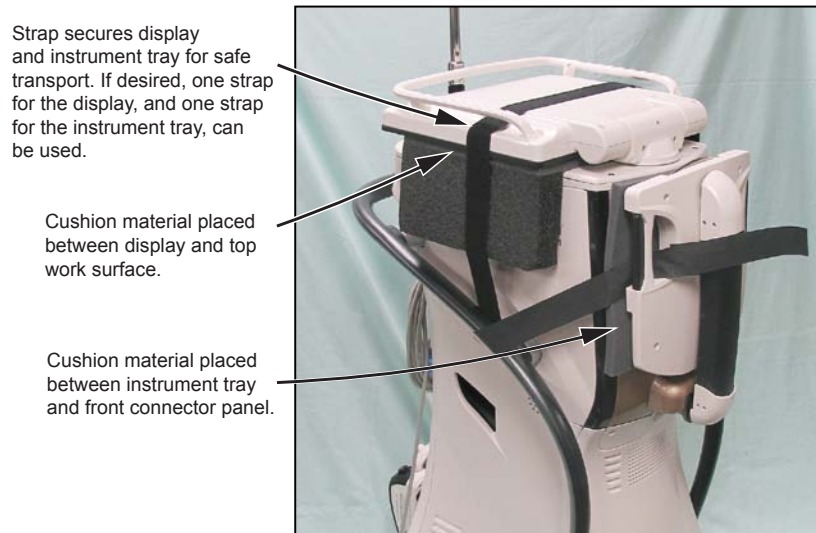
Figure 1-17 Example of Properly Packing the System for Transit

- 4.1 Using the photo shown in *Figure 1-17* as an example, secure the display screen and instrument tray as necessary in preparation for transit. **NOTE: Materials from the original shipping container are used in this example.**

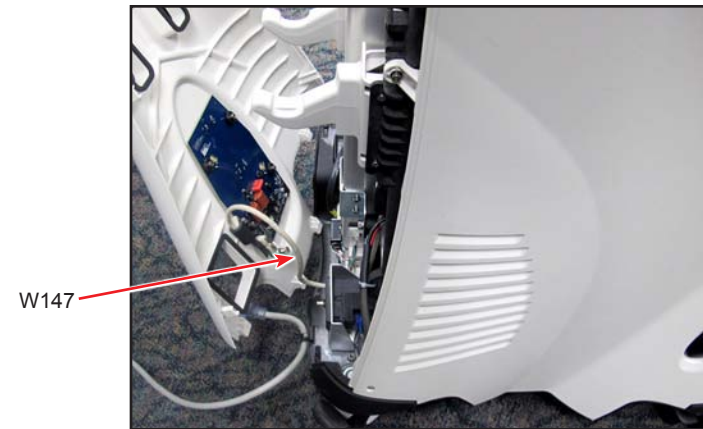
Figure 3-3 Cable W147 connecting Footswitch Charging PCB to MFIO PCBA

The Footswitch Charging PCB is mounted the Lower Rear Panel and is connected to the console (MFIO PCB) by W147 (see *Figure 3-3*). After removal, panel can be laid flat on floor without disconnecting cable.

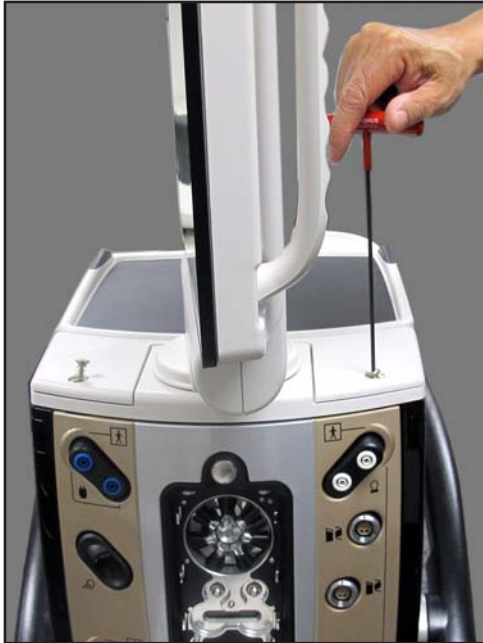
Figure 3-4 Captive Screws Securing Top of Upper Front Panel to Top Display Panel

- 4.1 Remove Front Vent Panel.
- 4.2 Turn Display as shown in *Figure 3-4*, and loosen two 3 mm captive screws securing top of Upper Front Panel to Top Display Panel.

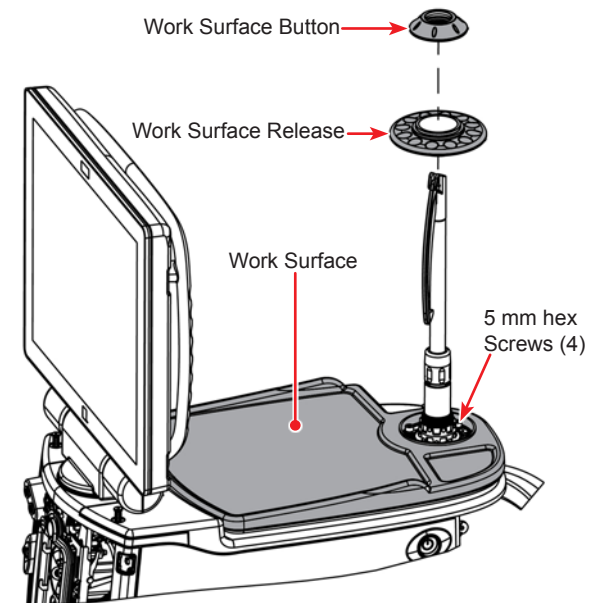
Figure 3-5 Removal of Work Surface Button and Release Button

- 8.1 Unscrew and remove Work Surface button (see *Figure 3-5*).

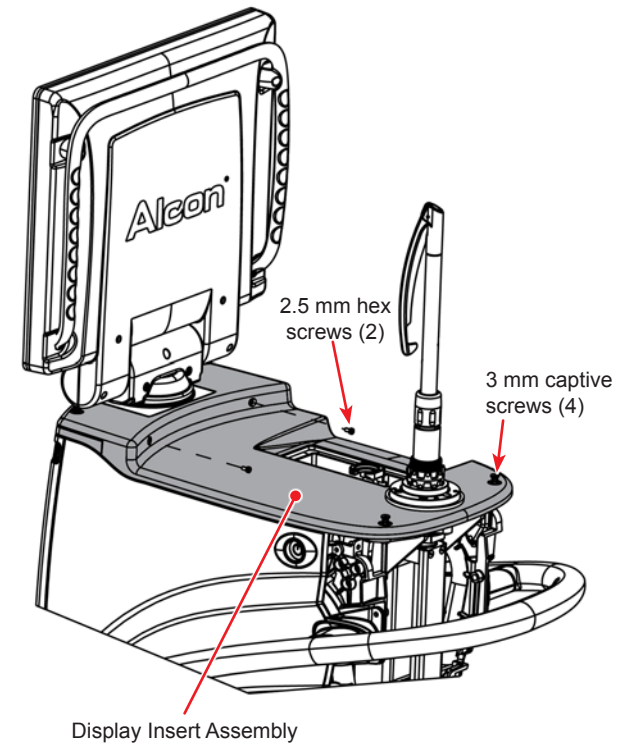
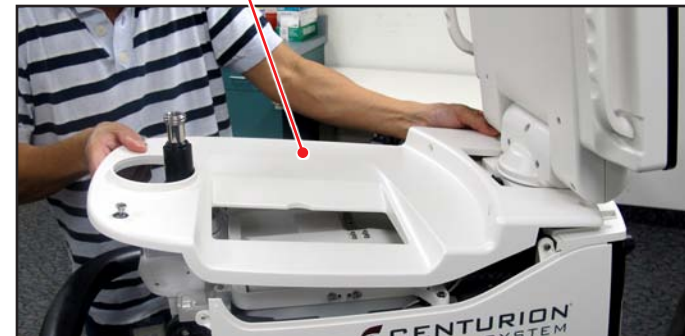
Figure 3-6 Removal of Display Insert Assembly

- 9.1 Remove Work Surface.
- 9.2 Loosen four 3 mm captive hex screws securing Display Insert to console (see *Figure 3-6*). Reposition Display as necessary to access screws.

- 9.3 Loosen and remove two 2.5 mm hex screws securing Display Insert to console.
- 9.4 Grasp one side of the front part of the Display Insert (near display) and the back of the panel (near the IV Pole), then lift the panel up and back until both parts of the panel have cleared the “lip” of the chassis underneath the Display Insert Panel (see photo in *Figure 3-6*). Leave Display Insert in this position.

- 9.6 Carefully lift and move Display Insert back taking care to reposition front captive screws and display as necessary to gain clearance. When clearance is achieved, remove Display Insert from console.

NOTE: There are concealed slots in the chassis that allow the captive screws to slide with panel as it is moved.

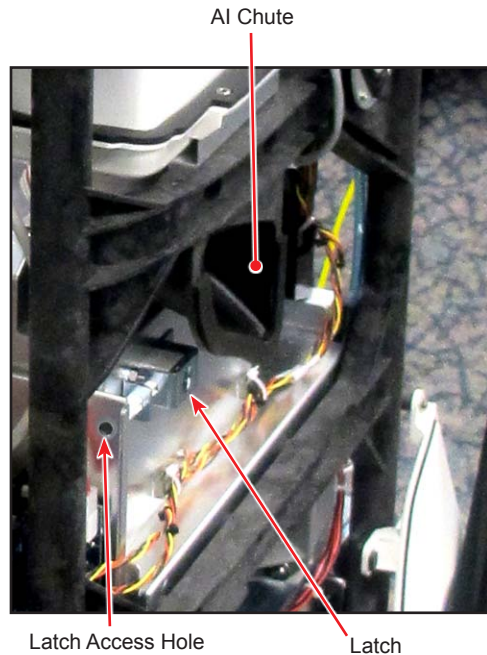
Figure 3-7 Lower Right Panel Latch Release (shown with panel removed)

- 13.1 Remove Upper and Lower Rear panels.
- 13.2 Remove Upper Right panel.
- 13.3 Remove six 3 mm hex screws and washers securing Lower Left Panel to console.
- 13.4 The panel is now held in place by a latch mechanism located just below the AI Chute in the console. The latch release is accessed from the rear through a hole in the sheet metal bracket that the MFIO PCB is mounted on (see *Figure 3-7*).

- 13.5 Insert a 4 mm hex wrench through the hole and into the white latch release button, then turn the button either clockwise or counter-clockwise to release the panel. Remove panel from console.

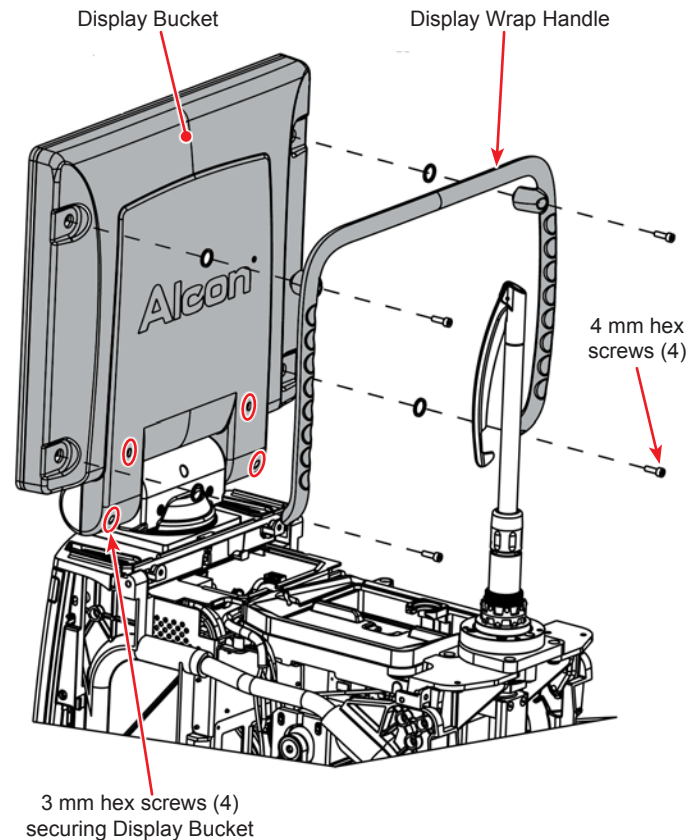
Figure 3-8 Display Wrap Handle and Display Bucket Removal

- 16.1 Remove four 4 mm screws securing Display Wrap Handle to display assembly. Remove Display Wrap Handle from system (see *Figure 3-8*).

REPLACEMENT: Be sure to install the Display Wrap Handle in the proper orientation. Installing handle upside down may result in a cracked display.

- 16.2 Remove four 3 mm hex screws securing Display Bucket to display assembly. Remove Display Bucket from system.

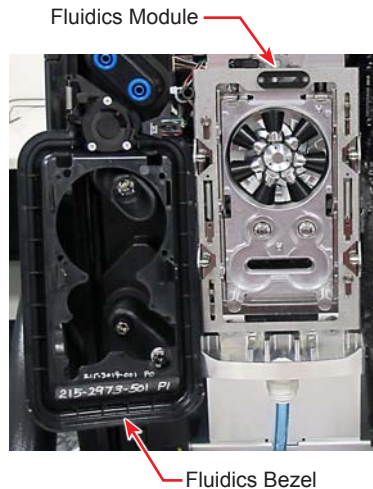
Figure 3-9 Fluidics Module with Bezel Removed

- 17.1 Remove Front Vent Panel, Upper Front Panel, and Lower Front Panel.
- 17.2 Remove black Fluidics Bezel by pulling it straight out from Fluidics Module. Bezel is attached to module by cable – allow bezel to hang freely in front of Fluidics Module during remainder of procedure (see *Figure 3-9*).

- After reconnecting J4, J5, J7, and J9, carefully slide both assemblies into console making slight adjustments as necessary to ensure PCB seats properly into Upper Backplane.
- When securing assemblies to console, alternately tighten screws to ensure proper seating of PCB.
- Ensure that ejection cable is not pinched between Fluidics Module and console frame (see *Figure 3-9*).

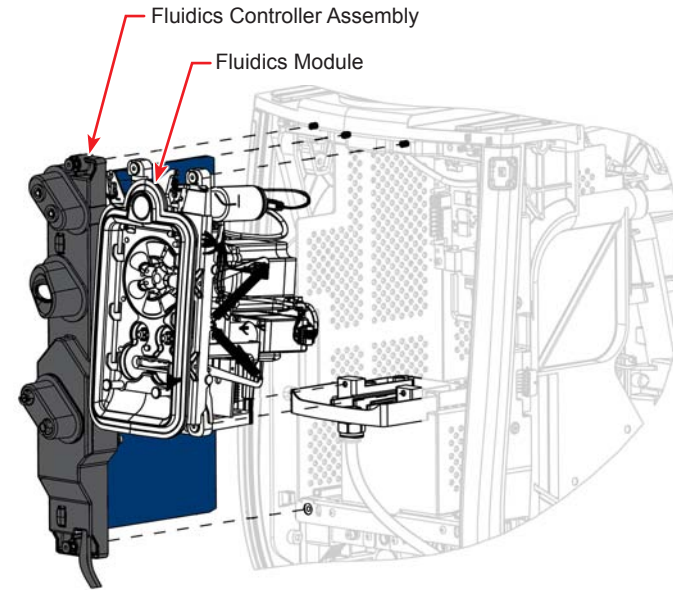
Figure 3-10 Fluidics Module and Fluidics PCB Assembly Removal

- 17.3 Loosen four 3 mm captive hex screws securing top and bottom of Fluidics Module to chassis (see *Figure 3-10*).
 - 17.4 Loosen two 3 mm captive hex screws securing Fluidics Controller Assembly to chassis.
 - 17.5 Disconnect yellow and blue pneumatic tubing from Pneumatic manifold (see *Figure 3-19*).
- REPLACEMENT:** Make note of tubing routing for replacement.
- 17.6 Carefully pull both assemblies out from console and set on a working surface.

- Use care to avoid damaging the cables between the module and PCB.
- Make certain to unlock the cable connectors from the PCB.

- 17.7 Disconnect J4, J5, J7, and J9 from Fluidics PCB. The two assemblies can now be separated.

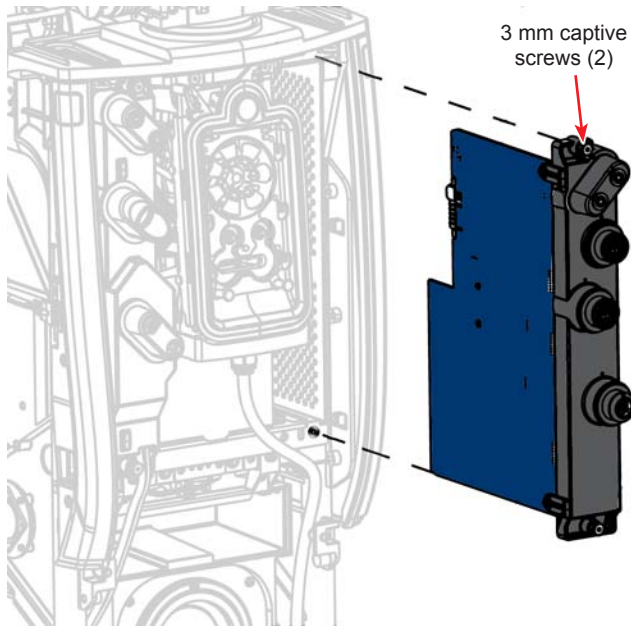
Figure 3-11 U/S PCB Assembly Removal

- 18.1 Remove Front Vent and Upper Front Panels.
- 18.2 Loosen two 3 mm captive hex screws securing top and bottom of U/S PCB Assembly to chassis.
- 18.3 Pull U/S PCB Assembly straight out from console and remove (Figure 3-11).

- Carefully slide assembly into place making slight adjustments as necessary to ensure PCB seats properly into upper backplane. Handpiece connector cables may need to be repositioned while assembly is sliding into place.
- When securing assembly to console, alternately tighten screws to ensure proper seating of PCB.
- HP Connector removal uses same tool as *Infiniti** Vision System.

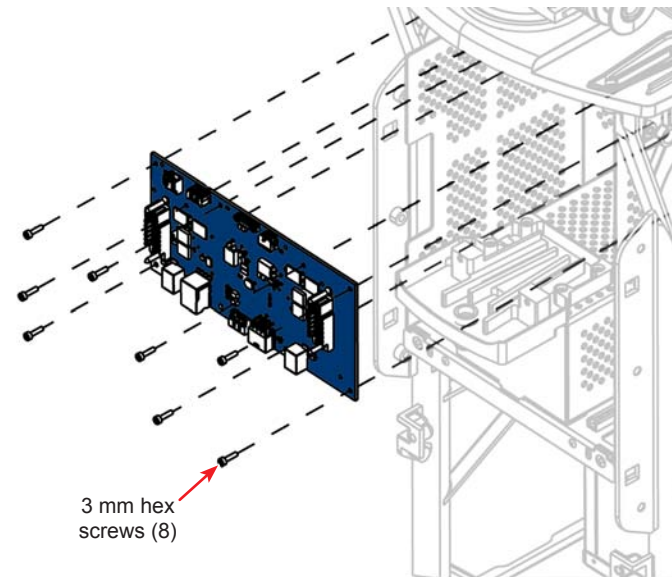
Figure 3-12 Upper Backplane PCB Removal

- 19.1 Remove Front Vent and Upper Front Panels.
- 19.2 Remove Fluidics Mechanism, Fluidics PCB, and U/S PCB Assemblies.
- 19.3 Disconnect J12, J16, J10 (may require screwdriver), J11, J4, J3, and J9 from Upper Backplane PCB.
- 19.4 Remove eight 2.5 mm hex screws securing Upper Backplane PCB to console.
- 19.5 Carefully pull Upper Backplane PCB off guide posts, rotate to clear display cables, and remove from system (Figure 3-12).

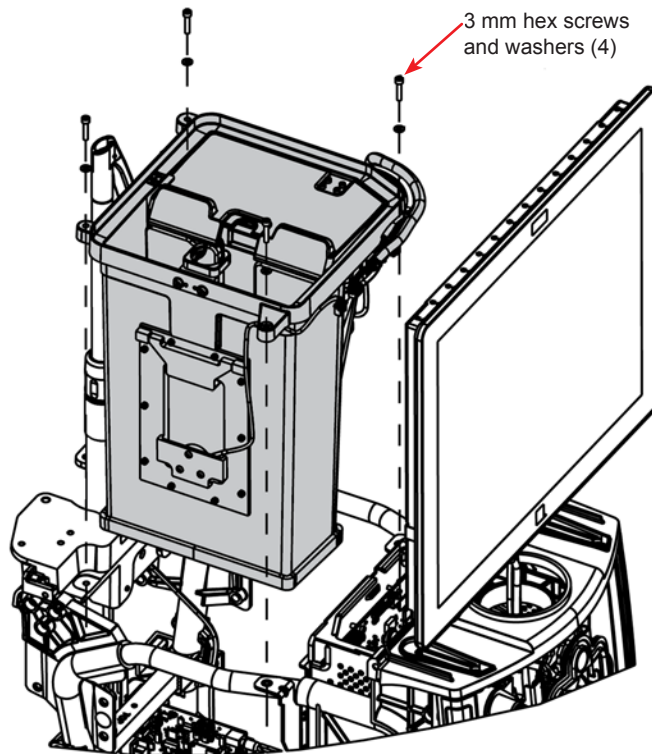
Figure 3-13 Active Irrigation Assembly Removal

- 20.1 Remove Display Insert Panel.
- 20.2 Disconnect J10, J11, J12, and J16 from Upper Backplane PCB.
- 20.3 Remove four 3 mm hex screws and washers securing AI Assembly to console.
- 20.4 Pull AI Assembly up and out of chassis moving the assembly as necessary to gain clearance for removal (see *Figure 3-13*).

REPLACEMENT: When lowering AI Assembly into console, ensure clearance of all cables. Assembly should not rest on or "pinch" any cables.

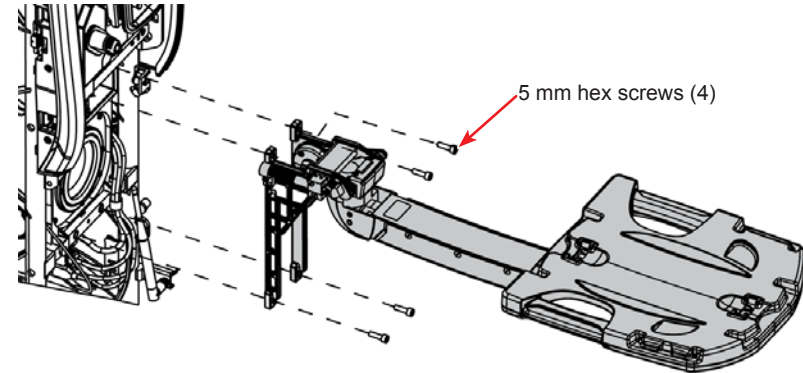
Figure 3-14 Tray Arm Assembly Removal

- 21.1 Remove Front Vent, Upper and Lower Front Panels.
- 21.2 Remove four 5 mm hex screws (bottom screws first) securing Tray Arm Assembly to chassis and remove from console (see *Figure 3-14*).

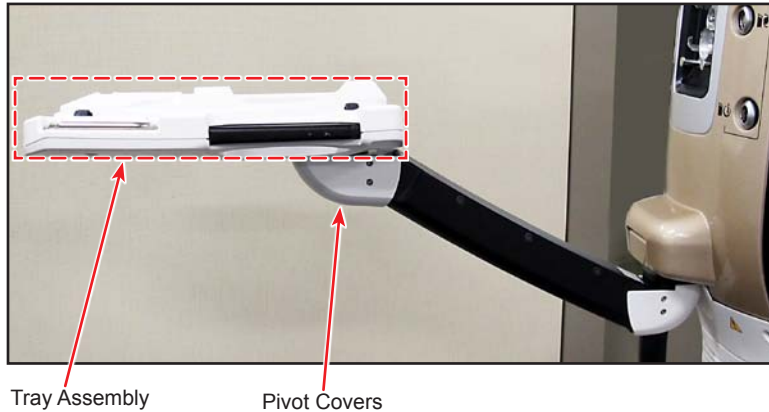
Figure 3-15 Tray Assembly at Highest Position

- 22.1 Raise the Tray Assembly to the highest position as shown in *Figure 3-15*.

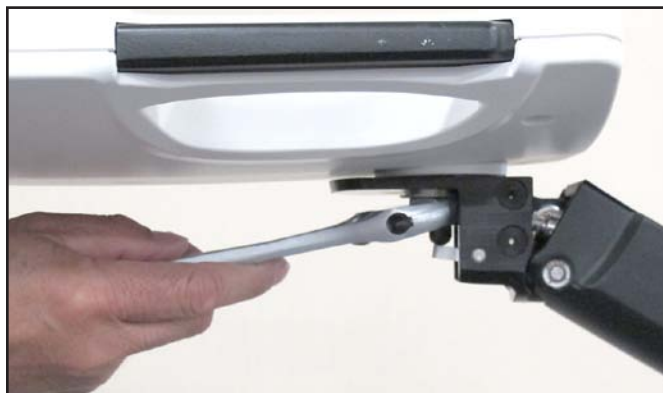
Figure 3-16 Tray Assembly Nut Removal

- 22.2 Remove four 2 mm hex screws securing left and right Pivot Covers. Remove covers from tray arm assembly.
- 22.3 Remove 1 inch nut securing Tray Assembly to Arm (see *Figure 3-16*). Be aware that there are washers and bearings behind the nut that may drop as the nut is removed (see *Figure 3-17*).

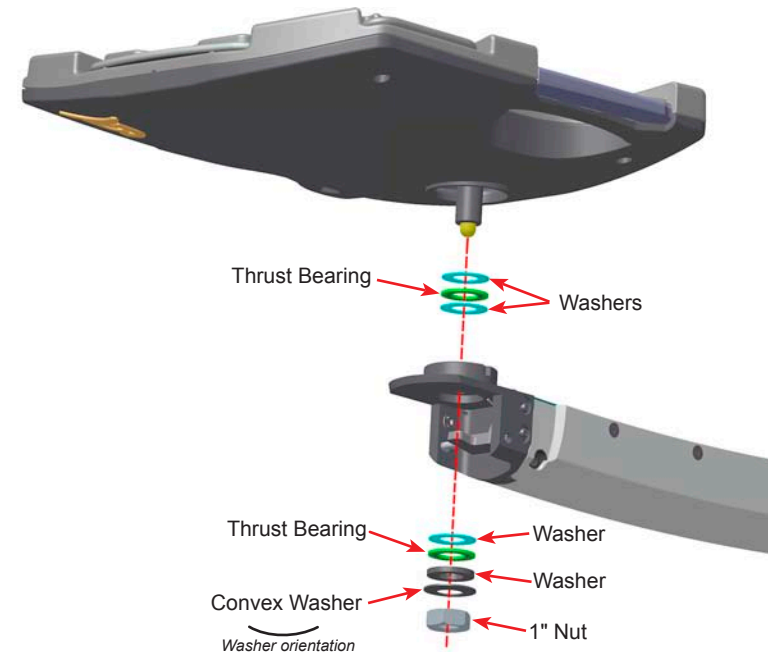
Figure 3-17 Washers and Bearings used to attach Tray Assembly to the Tray Arm

There are five washers and two bearings used to attach the tray assembly to the arm (see *Figure 3-17*). Ensure these washers and bearings are installed in the proper orientation otherwise the Tray Arm Assembly may not function properly.

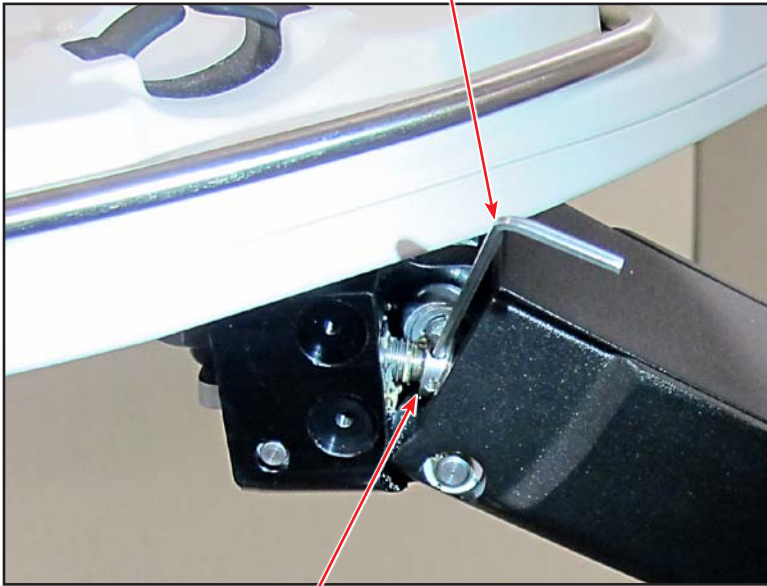
Figure 3-18 Adjusting Tray Arm Movement

- 22.6 Fully tighten 1 inch nut then loosen ½ turn.
- 22.7 Test Tray Arm movement to ensure it is working properly.
- 22.7.1 If Tray Arm is not moving properly when handles are pressed (unlocked), turn the adjustment nut backwards or forwards until it does move properly (see *Figure 3-18*). Ensure Tray Arm locks in position when handles are released and unlocks when handles are pressed.

Hex wrench - used to turn adjustment nut

Tray Arm Movement Adjustment Nut

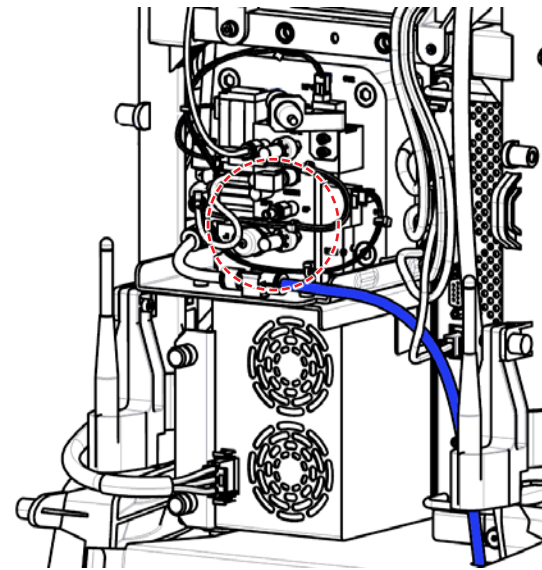
Figure 3-19 Pneumatic Tubing Connecting Pneumatic Manifold and Vit Pump

- 23.1 Remove Front Vent, Upper and Lower Front Panels.
- 23.2 Disconnect blue tubing between Pneumatic Manifold and Vit Pump (see *Figure 3-19*).
- 23.3 Disconnect yellow and blue tubing between Pneumatic Manifold and Fluidics PCB Assembly (see *Figure 3-20*).
- 23.4 Disconnect cable W133 connectors from Pneumatic Manifold (includes A28SENS1).
- 23.5 Loosen two 3 mm captive hex screws securing Pneumatic Manifold to chassis (see *Figure 3-21*).
- 23.6 Slide Pneumatic Manifold forward and remove from console.

- 25.1 Remove Front Vent, Upper and Lower Front Panels.
 - 25.2 Disconnect J10B (W164), J1A (W112), J1B (W126), J2 (W104), and J3 (W103) from Host Module.
 - 25.3 Disconnect blue tubing from Pneumatic Manifold (provides clearance to remove Host module - see *Figure 3-19*).
 - 25.4 Loosen two 2.5 mm captive screws securing Host Module to chassis (see *Figure 3-23*).
 - 25.5 Pull Host Module forward while repositioning pneumatic tubing and cables to provide clearance for module removal. Remove Host Module from console.
- REPLACEMENT:** Carefully slide Host Module into console until it engages connector and is properly seated in place.

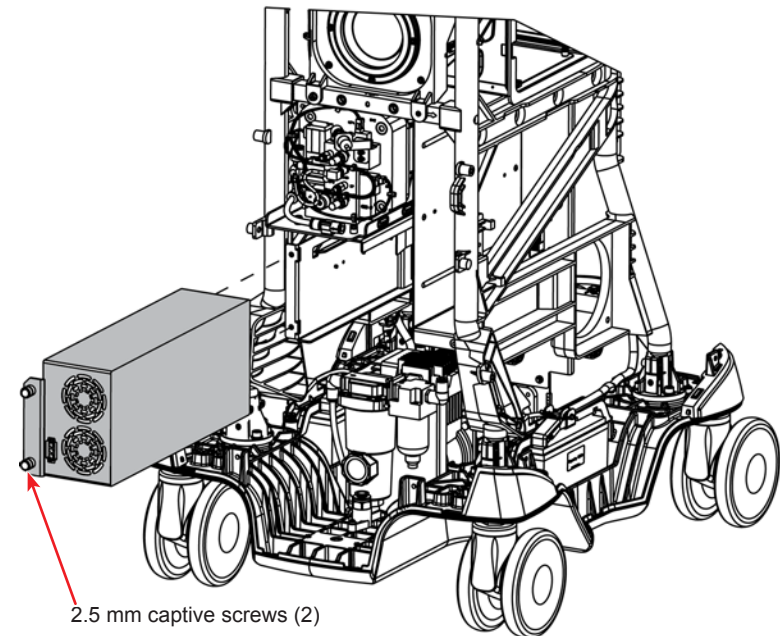
Figure 3-22 Power Supply Removal

- 24.1 Remove Front Vent, Upper and Lower Front Panels.
- 24.2 Disconnect W111 P1 from Power Supply.
REPLACEMENT: Antenna should be pointing up with Power Supply cable routed around it.
- 24.3 Loosen two 2.5 mm captive hex screws securing Power Supply to chassis (see *Figure 3-22*).
- 24.4 Slide Power Supply forward, adjusting position as necessary to clear antenna, and remove from console.

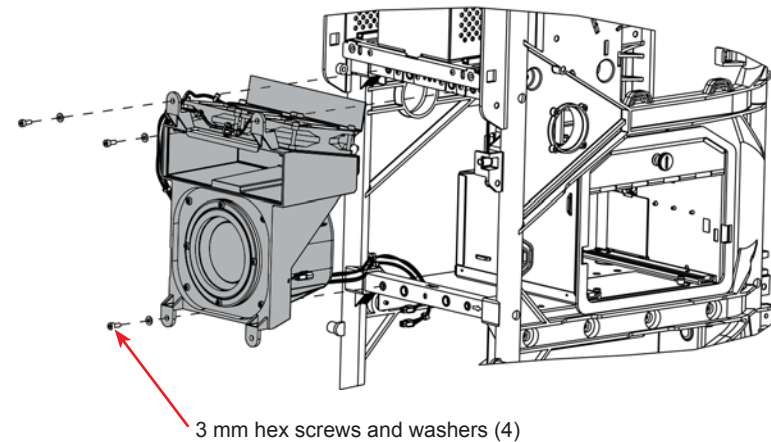
Figure 3-24 Filter/Subwoofer Box Removal

- 26.1 Remove Front Vent, Upper and Lower Front Panels.
- 26.2 Disconnect J1 from Sub-woofer.
- 26.3 Disconnect J18 and J35 from MFIO PCB.
- 26.4 Cut tie wraps securing W129-1 and W129-2 to chassis.
- 26.5 Remove four 3 mm hex screws and washer securing Sub-woofer/fan assembly to chassis (see *Figure 3-24*).
- 26.6 Carefully pull Filter/Subwoofer Box forward to remove from system.
- 26.7 FAN REMOVAL
 - 26.7.1 To remove fans from assembly, remove four 3 mm hex screws securing bracket to assembly.
 - 26.7.2 Remove two 3 mm hex screws securing front of fans to assembly. Cut tie wraps as necessary and remove fan(s).

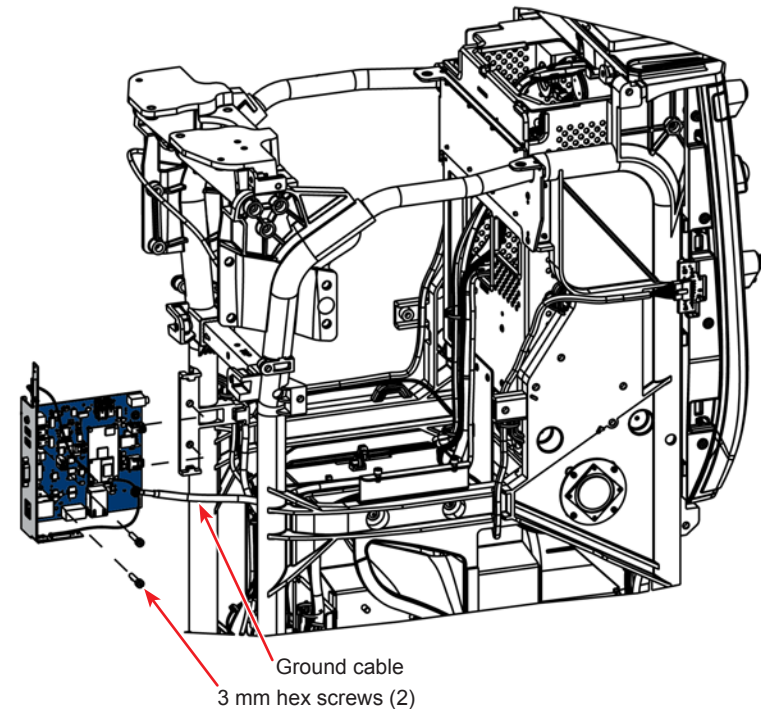
Figure 3-25 Rear Panel I/O-Wireless Module Assembly Removal

- 27.1 Remove Upper Rear, Lower Rear, and Upper Left Panels.
- 27.2 Remove 40 A fuse from MFIO PCB (in case hardware is dropped).
- 27.3 Disconnect J4, J5, J7, and J10 from Wireless PCB.
- 27.4 Remove 2.5 mm hex screw and star washer securing ground terminal lug to Wireless PCB.
REPLACEMENT ORDER: From PCB – star washer/terminal lug/hex screw
- 27.5 Remove two 3 mm hex screws securing Rear Panel I/O-Wireless Module Assembly to chassis (see *Figure 3-25*).
Screws are accessed from inside chassis; removal of lower right panel may be necessary.
- 27.6 Slide Rear Panel I/O-Wireless Module Assembly straight back and out of console.

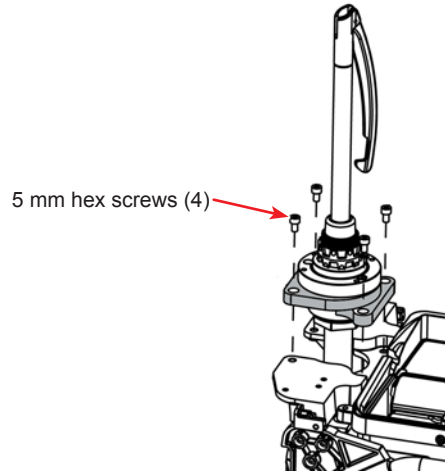
Figure 3-26 Work Surface Hub Removal

- 28.1 Remove Work Surface and Display Insert Assembly.
- 28.2 Remove Upper and Lower Rear Panels.
- 28.3 Remove four 5 mm hex screws securing work surface hub at top of IV Pole Assembly to chassis. Slide hub up and remove from IV Pole Assembly (see *Figure 3-26*).

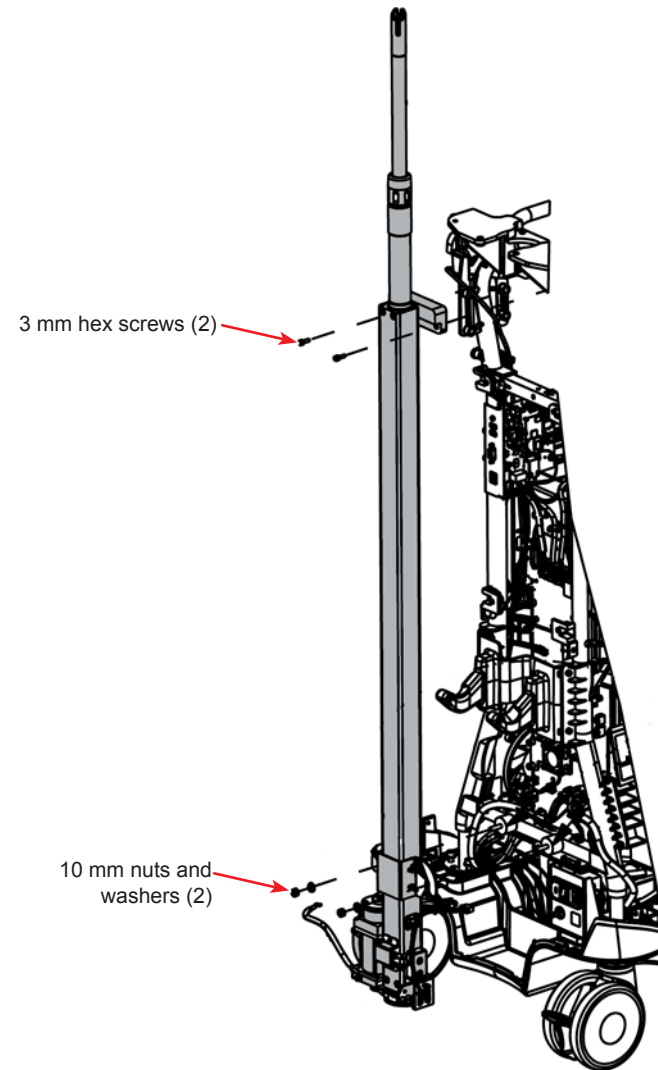
Figure 3-27 IV Pole Assembly Removal

- 28.4 Remove two 3 mm hex screws securing inside top of IV Pole Assembly to chassis (see *Figure 3-27*).
- 28.5 Loosen two 10 mm nuts and washers securing bottom of IV Pole Assembly to standoffs on chassis. Nut do not need to be completely removed (see *Figure 3-27*).

REPLACEMENT: Do not tighten nuts until two 3 mm hex screws at inside top of assembly are in place.

- 28.6 Disconnect J5 and J23 from bottom of MFIO PCB.
- 28.7 Remove 3 mm hex screw securing ground terminal lug to IV Pole Assembly.
- 28.8 Lift IV Pole Assembly upward until there is enough clearance to remove assembly from console.

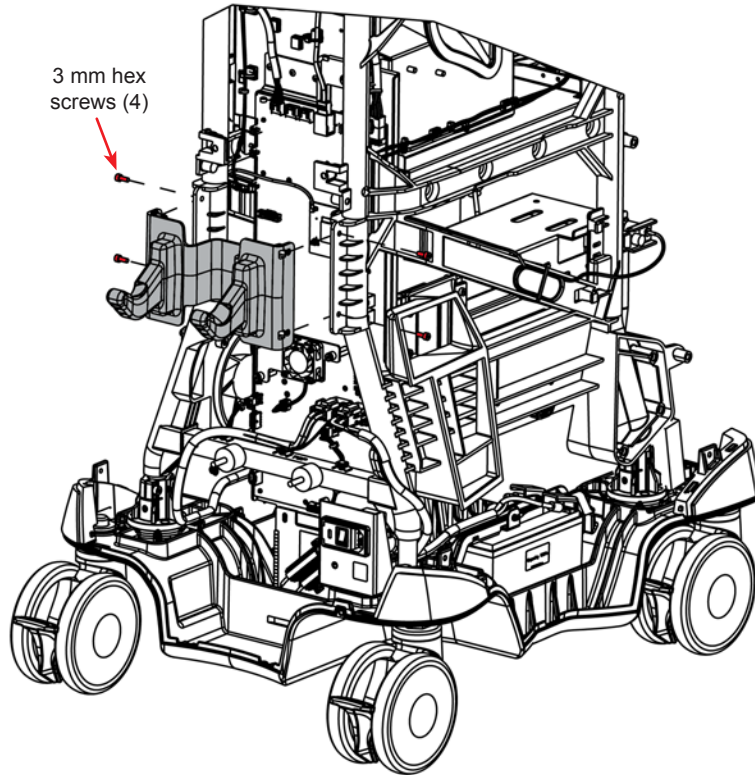
Figure 3-28 Footswitch Hook Removal (shown with IV Pole removed)

- 29.1 Remove Upper and Lower Rear Panels.
- 29.2 Remove four 3 mm hex screws securing footswitch hanger to chassis (see *Figure 3-28*).
- 29.3 Slide Footswitch Hook up to provide clearance then rotate around IV Pole and remove from console.

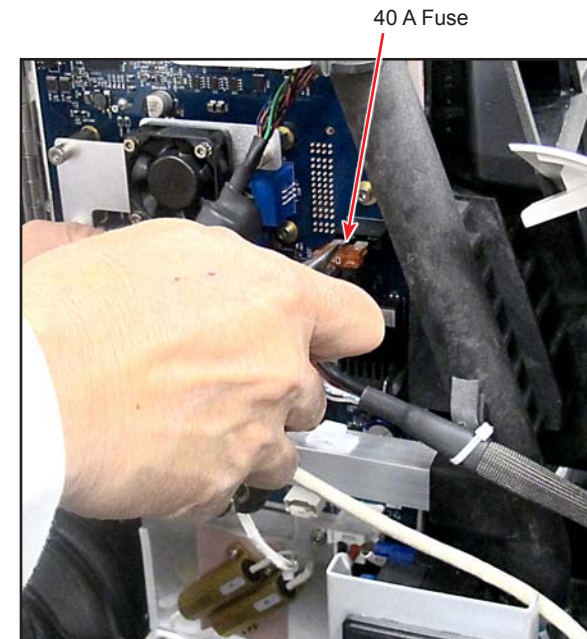
Figure 3-29 40 A fuse on MFIO PCB

- 30.1 Remove Upper and Lower Rear Panels.
- 30.2 Remove Footswitch Hook.
- 30.3 Remove 40 A fuse from MFIO PCB (see *Figure 3-29*).

- 2.4 Lift panel up to clear tabs securing bottom of panel, then remove from console. Lay panel on floor next to console.
- 2.5 *To completely remove panel from system:*
 - 2.5.1 Remove 40 A fuse on MFIO PCB (see *Figure 3-29*).
 - 2.5.2 Disconnect cable W147 from console connectors J25 and J39 of MFIO PCB.

- 31.1 Remove Upper and Lower Rear Panels.
- 31.2 Remove Footswitch Hook.
- 31.3 Remove 40 A fuse from MFIO PCB (see *Figure 3-29*).
- 31.4 Remove battery BT1 (CR 2032) from MFIO PCB by pulling clip away from battery, then sliding the battery forward. See *Figure 3-30* for battery location.

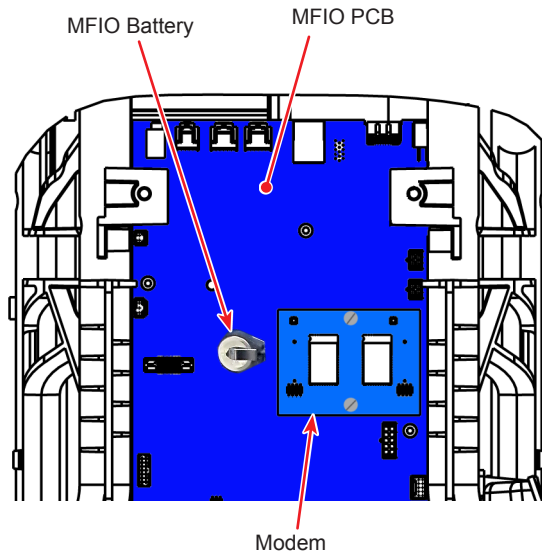
Figure 3-30 MFIO Modem Removal

- 30.4 Disconnect modem connectors J1 and J4.
- 30.5 Carefully remove two standard screws securing Modem PCB to MFIO PCB (see *Figure 3-30*).
- 30.6 Pull Modem PCB off two connectors on MFIO PCB and remove from console.

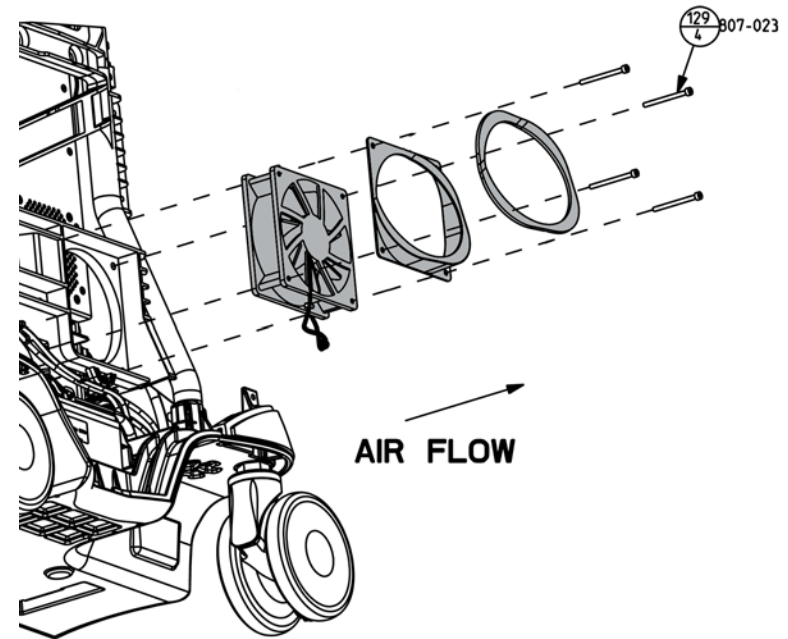
- 33.1 Remove Upper and Lower Rear Panels.
- 33.2 Remove Upper and Lower Left Panels.
- 33.3 Remove four 3 mm hex screws securing fan and duct to chassis (see *Figure 3-32*). **NOTE: Fan is still connected to MFIO PCB by cable.**
- 33.4 Pull fan from console and disconnect from J17 on MFIO PCB.

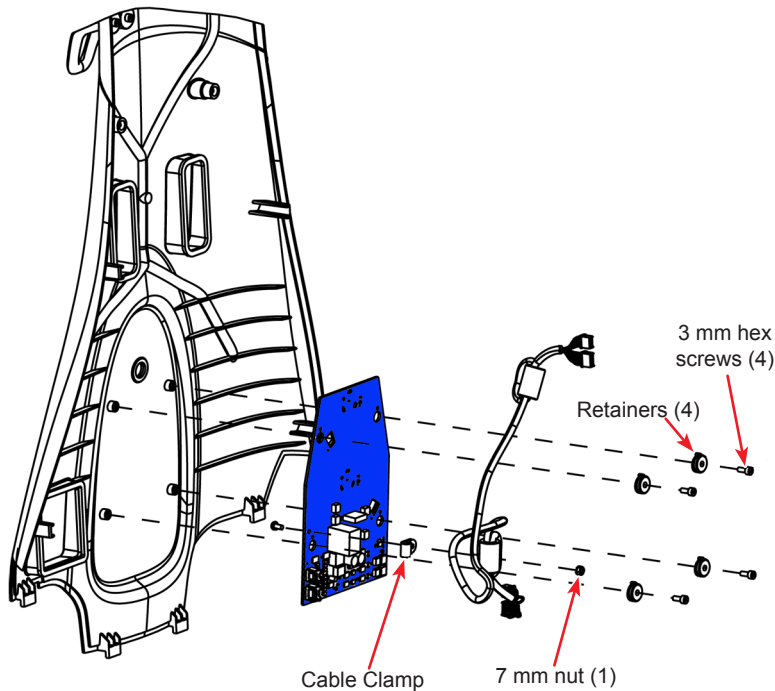
Figure 3-33 Footswitch Charger PCB Removal

- 34.1 Remove Upper and Lower Rear Panel.
- 34.2 Disconnect J1 and J2 from Footswitch Charger PCB.
- 34.3 Remove 7 mm nut and star washer securing cable clamp for W147 to panel.
- 34.4 Remove four 3 mm hex screws and black retainers securing Footswitch Charger PCB to panel.
